A Strategy for East Farleigh Bridge

Ensuring the Safety of Pedestrians, Improved Traffic
Management and the Preservation of the Bridge
East Farleigh Parish Council

May 2017

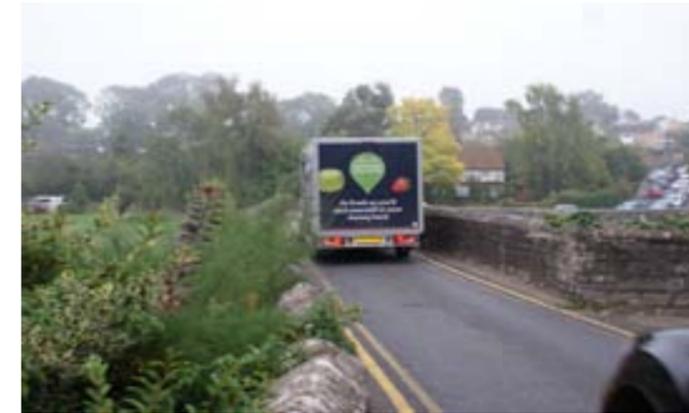
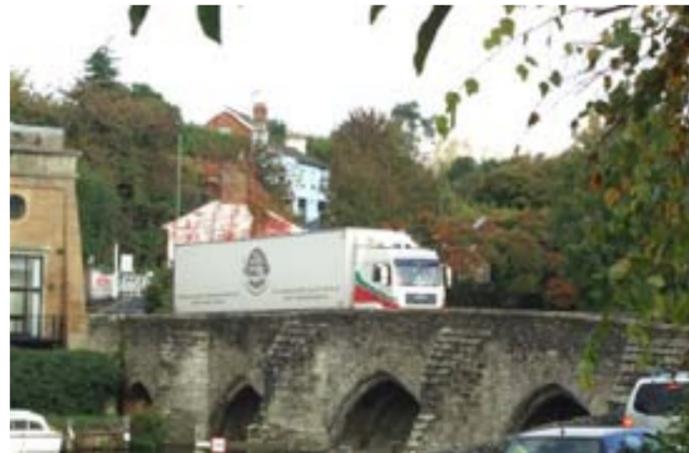
Above: Tesco deliver van crossing the bridge
Below: Large HGV crossing the bridge

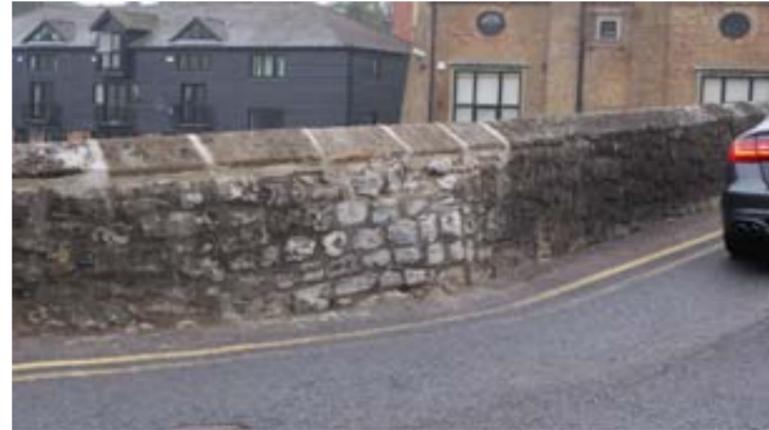
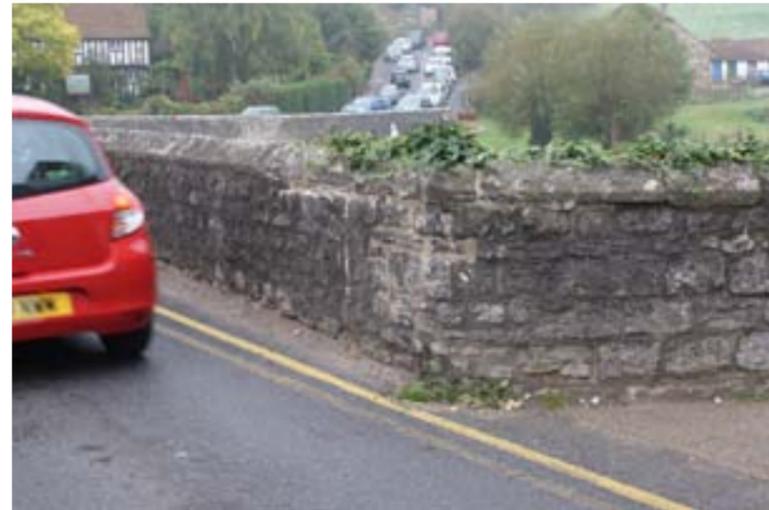
Above and Below: Repaired damage to north and south western corners of bridge. Example of how new stonework is unsympathetic to historical masonry.

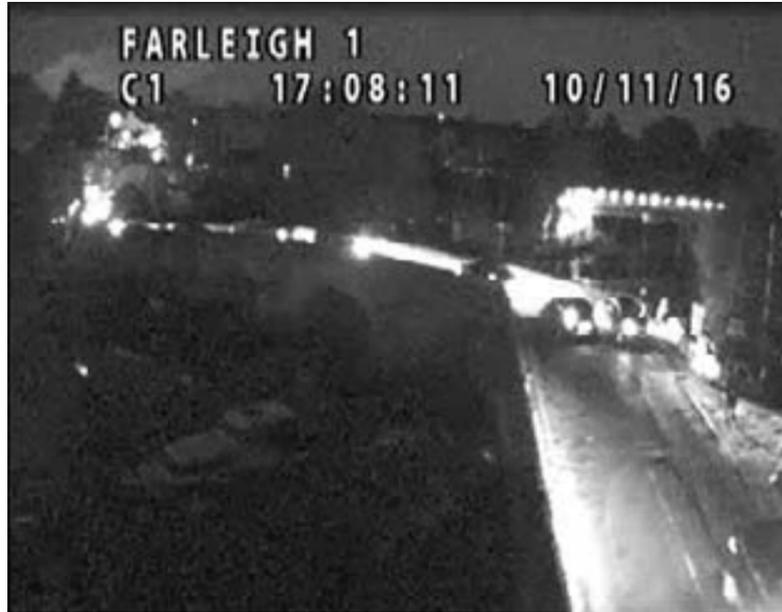
Figure 0-1: Vehicle Conflict- Reversing Vehicle Movements (Camera 1)

In the majority of instances, the vehicles travelling northbound subsequently reversed to make way for the southbound drivers. This was primarily due to fewer northbound vehicles having entered the bridge, due to the enhanced forward visibility in this direction. In addition, on the southern side of the bridge there is a greater area for manoeuvres to be undertaken, although in many cases, reversing drivers failed to position themselves within the correct side of the carriageway, often constraining the movements of oncoming traffic, as shown in Figure 0-1.

It is evident that the majority of northbound vehicles seeking to cross the bridge waited behind Camera 1, within the vicinity of the informal layby approximately 40 metres to the south, when opposing vehicles were crossing. Vehicles edged forward from this location when a break was observed in the oncoming vehicle flow, which occasionally resulted in conflict as outlined above, as their forward movement constrained visibility of oncoming traffic.

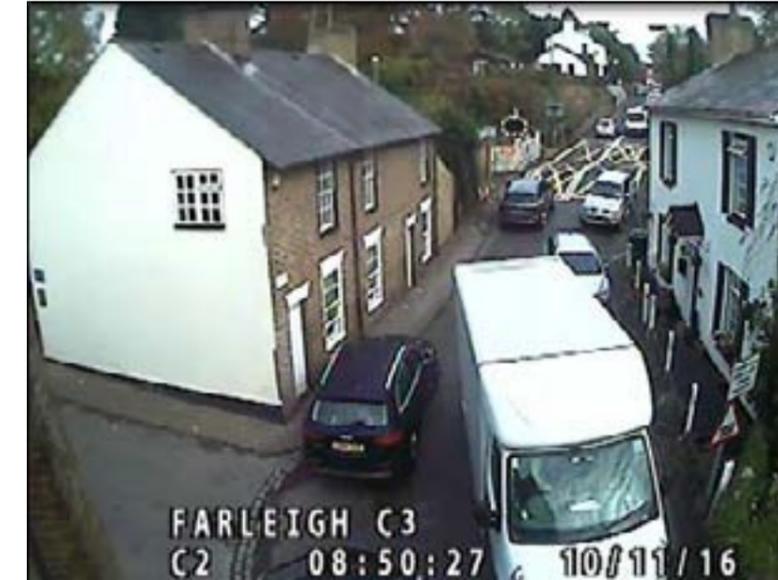
Figure 0-2: Vehicle Conflict- Farleigh Lane

On the northern side of the bridge, it was observed that due to the restricted forward visibility for southbound traffic, a number of 'false starts' occurred, whereby vehicles moved from their waiting point, only to be forced back by oncoming vehicles which they had failed to observe. The space constraints in this area mean that southbound vehicles tend to wait close together and therefore when a vehicle makes a false start, there is limited opportunity for them to reverse. This results in vehicles passing in very close proximity to one another, with a number of near misses observed, as shown in Figure 0 2 below. Vehicles also pass exceptionally close to the houses on the western side of Farleigh Lane, often overrunning the footway in this location.

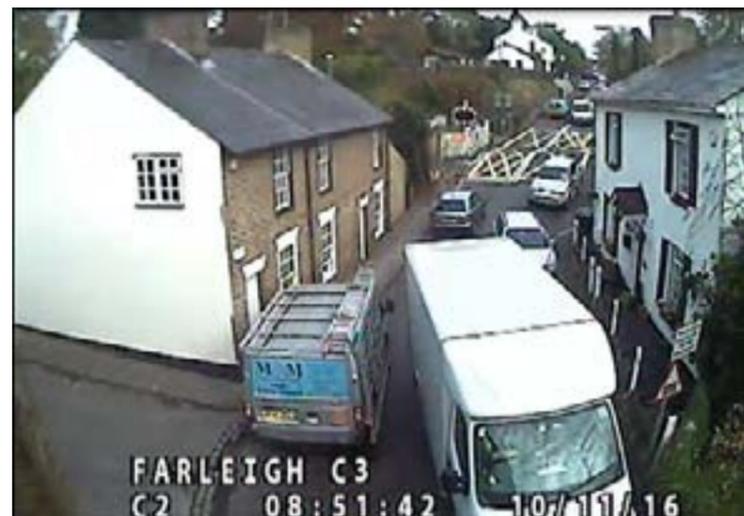
Figure 0-3: Vehicle Conflict- LGV Movements

It is noted that the majority of vehicles crossing the bridge were cars, although a significant proportion were LGV movements such as supermarket delivery vehicles and vans. LGVs accessing the bridge have to utilise the full width of the carriageway, which can cause issues of obstruction, particularly where two LGVs meet, as shown in Figure 0 3.

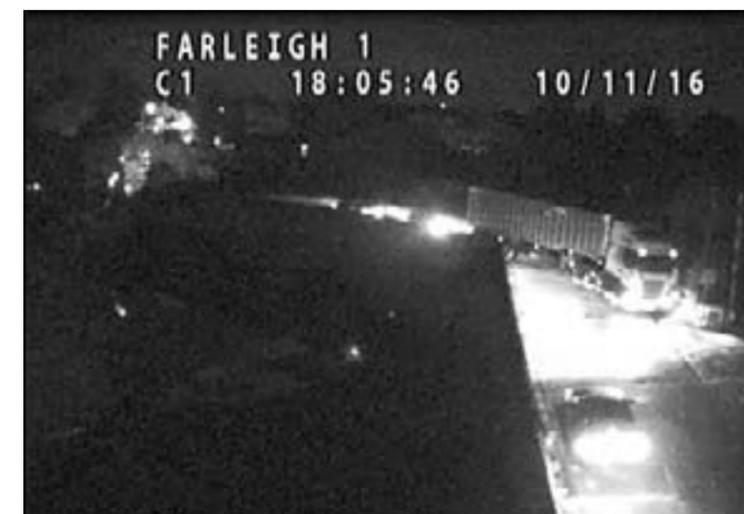
Figure 0-4: Vehicle Conflict- OGV Movement

Whilst only 0.1 per cent of the total vehicle flows were OGVs – which are prohibited from crossing the bridge by the 2.0m width restriction – it is noted that these vehicles caused significant issues of obstruction. At 18:03, an OGV attempted to cross the bridge southbound. The driver was apparently unaware of the restricted width of the bridge, as the vehicle remained stationary for a number of minutes before proceeding. In this time, vehicles travelling northbound entered the bridge and were subsequently forced to reverse to make way for the OGV. As Figure 0 4 depicts, on exiting the bridge the OGV had limited room to manoeuvre, due to queueing traffic in the opposing direction. This resulted in the OGV passing close to the Grade 1 Listed bridge wall.

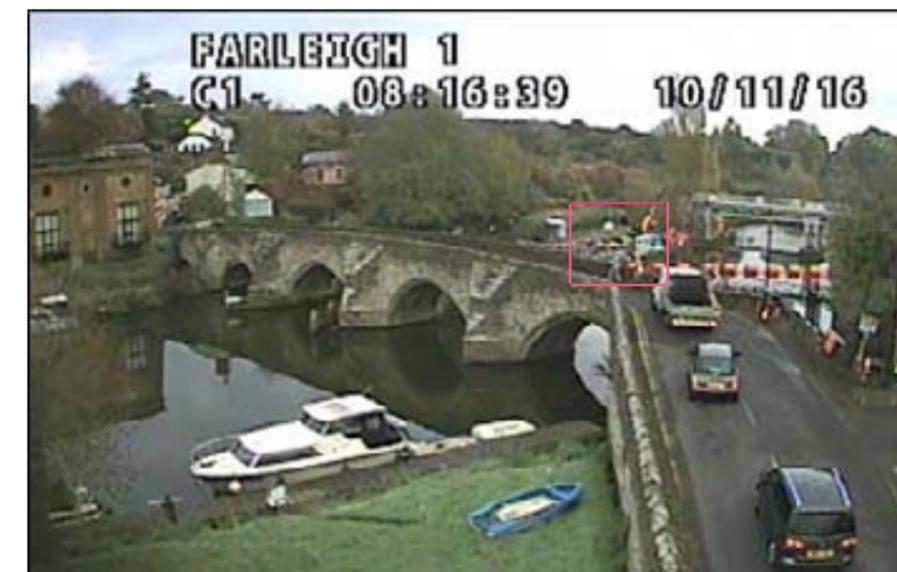
Figure 0-5: Pedestrian / Vehicle Conflict- Van Approaching

A total of 22 pedestrians crossed the bridge during the morning peak period (07:00 to 10:00) and 31 pedestrians crossed during the evening peak period (16:00 to 19:00). Due to the restricted width of the bridge, all of the pedestrians came into close contact with vehicles. This was particularly notable when a van crossed the bridge, as shown in Figure 0-5 and Figure 0-6.

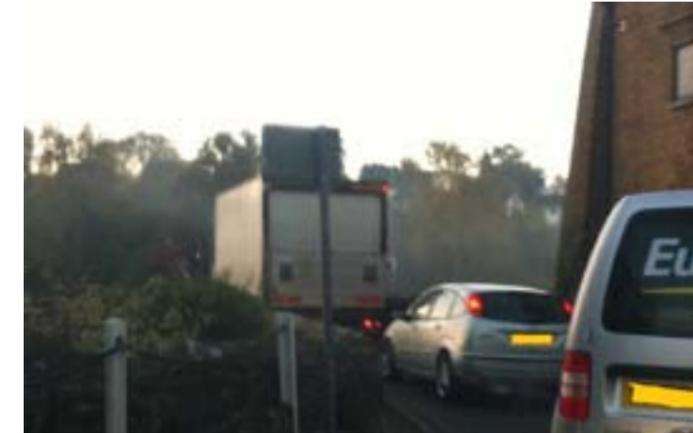
Above: A pedestrian is located to the left of the small lorry crossing the bridge behind the vegetation, highlighting the little room between the two.

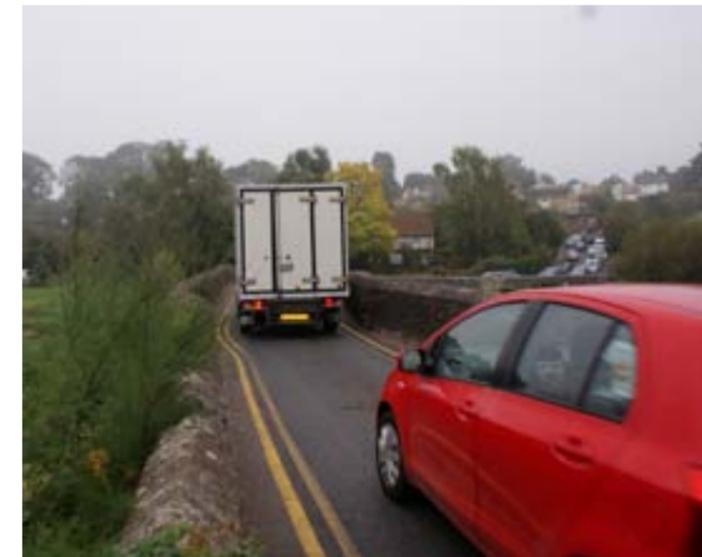
Below: An image of another small lorry crossing the bridge highlights the significant lack of room available to pedestrians when over sized vehicles cross

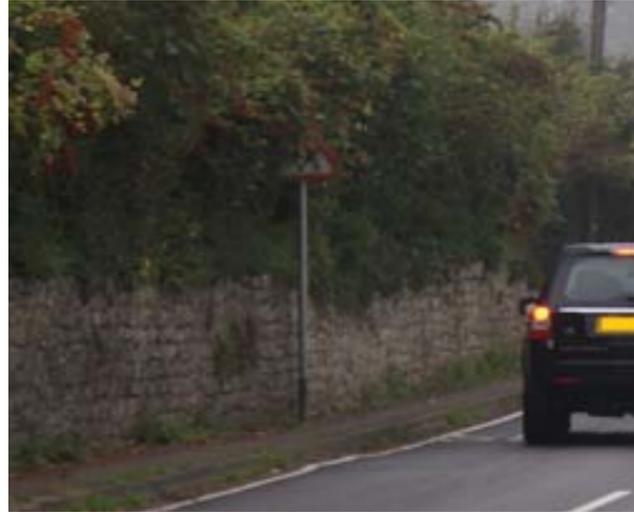
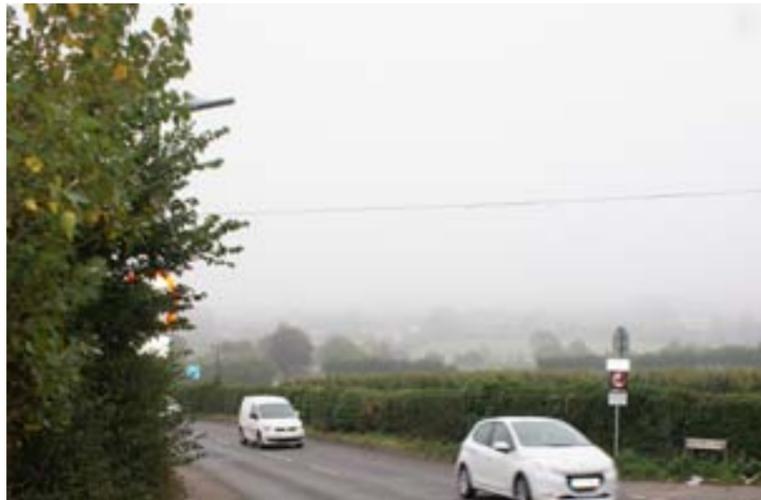
Above: View looking east on Lower Road showing school pedestrian crossing sign which is becoming hidden by vegetation
Below: View looking south along Farleigh Lane showing a hidden HGV sign on the left and a twisted sign on the right

As an initial stage in the long term management and prevention of HGV movements across the bridge, it is proposed that all vegetation that encroaches onto highway land is regularly maintained to ensure that it does not obscure or cover any existing signage that seeks to prevent access by unsuitable vehicles. It has been noted that a number of advance warning signs were poorly maintained and were consequently not clearly visible to passing motorists, as can be seen in the images opposite.

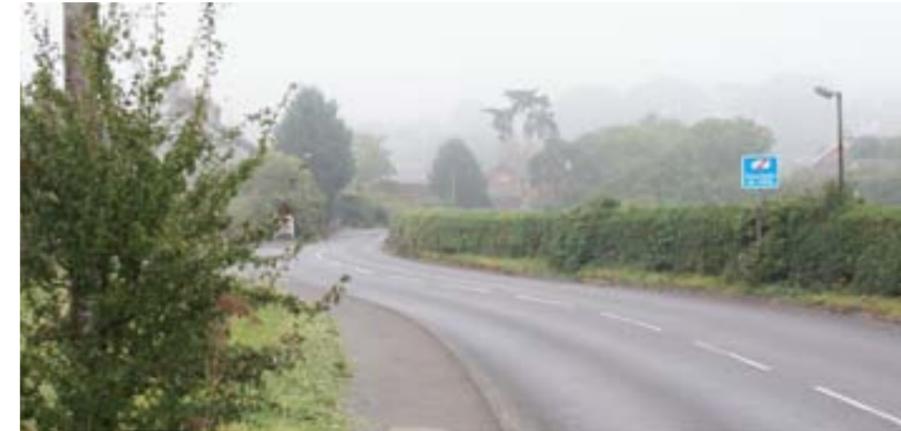
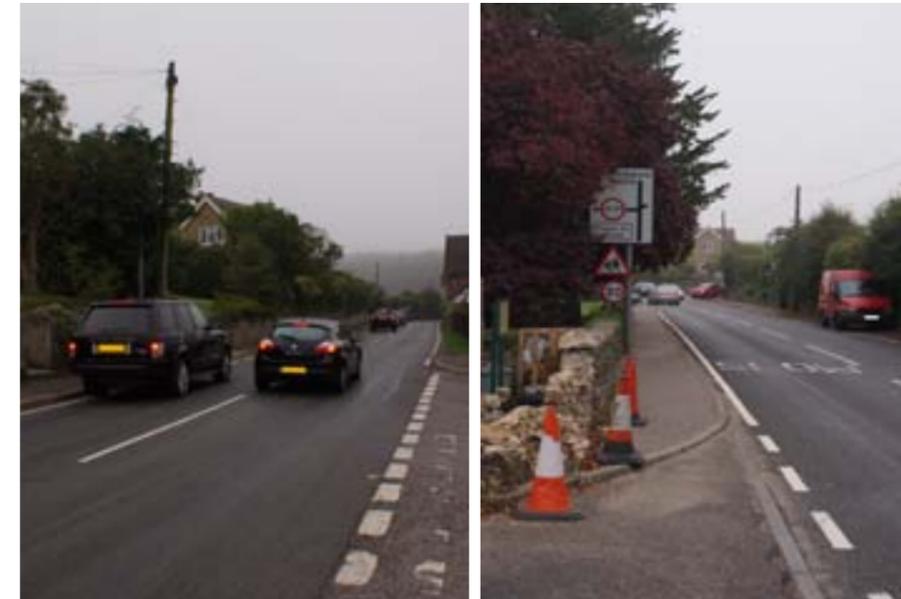
Above: Existing signage on Farleigh Lane
Below: Views on the approach to Station Hill along Lower Road showing no signage on the eastern approach and very little signage on the western approach.

Aligned to the previous recommendations, it is proposed that the existing signage that forewarns drivers of the width restriction should be replaced with newer, more visible signage as has been achieved in other villages within the Borough of Maidstone, including Harrietsham and Lenham. The existing signage is not sufficient in preventing HGVs and it is therefore necessary to find an appropriate long-term solution.
