A Strategy for East Farleigh Bridge

Ensuring the Safety of Pedestrians, Improved Traffic
Management and the Preservation of the Bridge
East Farleigh Parish Council

May 2017

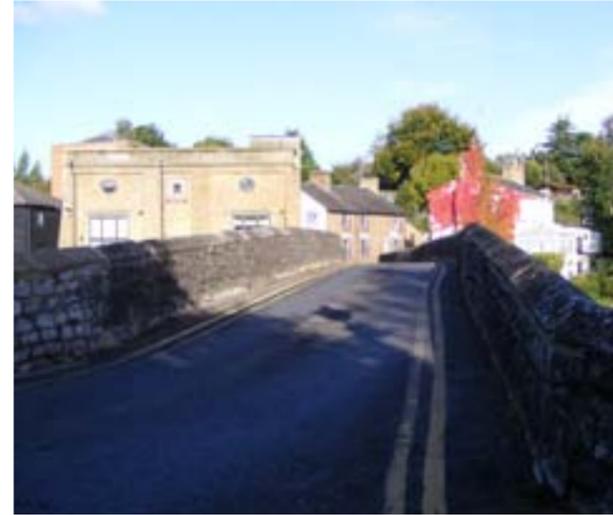
Left: View across the East Farleigh Bridge
Below: Signage to prevent foreign HGV drivers located on Farleigh Lane

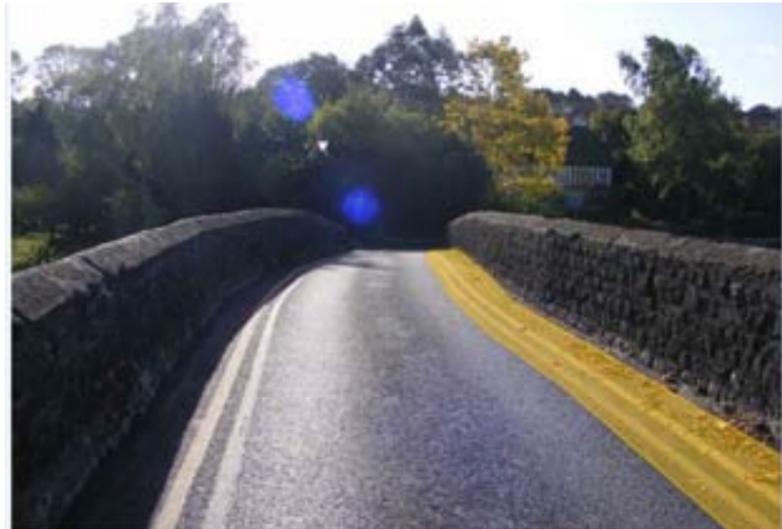
Above: Concept view of proposed change in colour of carriageway surface

As the width of the bridge cannot be altered, surface treatment works are considered to represent the only feasible option for providing a distinctive area that pedestrians and cyclists can use which is obvious to drivers and promotes better lane discipline. It is considered that simple line markings and surface treatments should be used, as these would not impact upon the construction or design of the bridge and would simply alter the colour of the asphalt surfacing across it. The colour of this surfacing could reflect the colour used for bus and cycle lanes, which drivers are familiar with negotiating in the course of their daily journeys.

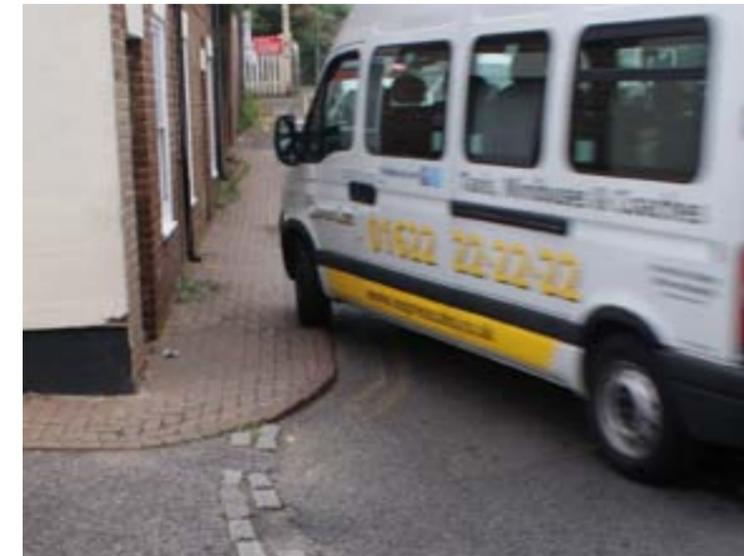
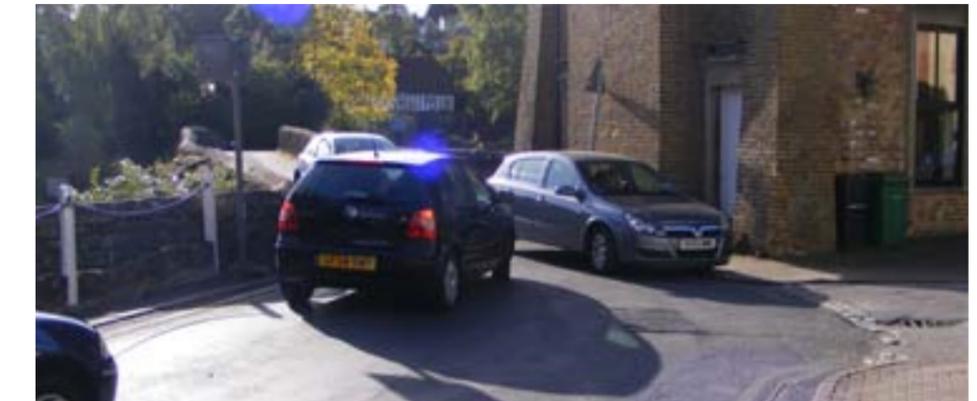
In addition to the hazards facing pedestrians crossing the bridge, it is apparent that a number of vehicles also over-run the footway on Farleigh Lane, adjacent to the junction with Riverside Park, as is evidenced in the images opposite. This issue is of understandable concern to local residents as they cannot walk on dedicated footways without the risk of coming in to conflict with passing vehicles.

These incidents are understood to occur as a consequence of northbound motorists manoeuvring around opposing vehicles waiting to cross the bridge in a southerly direction and is compounded by the worn lining on the carriageway. It is also considered that the height and colour of the footway are not sufficiently different to the carriageway to dissuade drivers from attempting these manoeuvres. The culmination of each of these factors further exacerbates the safety implications presented to pedestrians in this part of the village, particularly for vulnerable users such as parents with small children and the disabled, who may be obscured from the drivers' view.

In an attempt to address this issue, it is proposed that new markings on the local roads are provided to more prominently demarcate the carriageway and the footway. It is unfortunate that the limited availability of highway land in this location currently prevents the relocation of the footway.
